# **NAVAL WEAPONS STATION SEAL BEACH FLEET MOORINGS INSPECTION REPORT**

Results indicate a majority of the moorings are in satisfactory condition; however, because of the normal cycle of chain deterioration, several of the moorings are in need of immediate attention. Comments concerning the conditions of those in the latter category, along with recommended maintenance actions, are included.

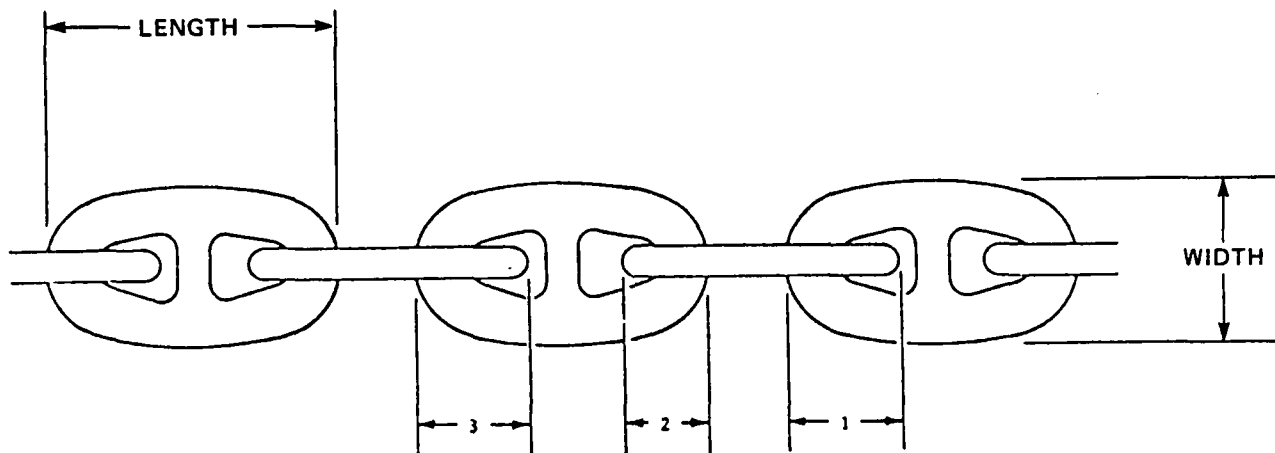
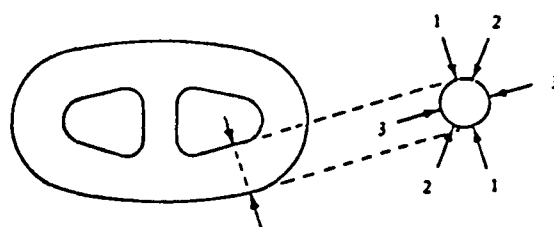
FIGURE 2. LOCATIONS FOR TAKING CHAIN LINK MEASUREMENTS

One of the more important parameters used to evaluate the condition of a mooring is chain wire diameter. After cleaning to bare metal, a selective sampling of the wire diameter of chain links and connecting hardware is taken in order to determine the amount of deterioration due to corrosion and wear. "Single Link" measurements are taken where chain is slack, and detect only corrosion loss. "Double Link" measurements, taken where two links connect under tension, detect the combined effects of corrosion and wear. Figure 2 shows how these measurements are made. Chain links and other components which measure 90% (+90%) or greater than the original wire diameter are considered in "good" condition; measurement

between 80% and 90% of original diameter is considered "fair" condition and is cause for the mooring to be downgraded to the next lowest classification; any measurement less than 80% is considered "poor" and is cause for the mooring to be declared unsatisfactory for fleet use.

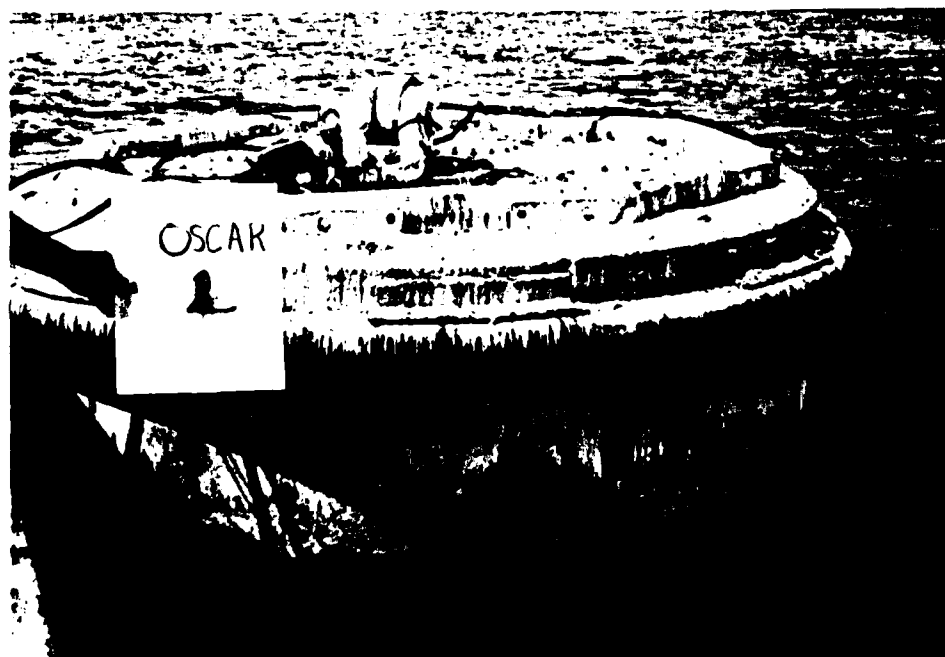
Oscar 2 — Pitting, rusting on side of buoy

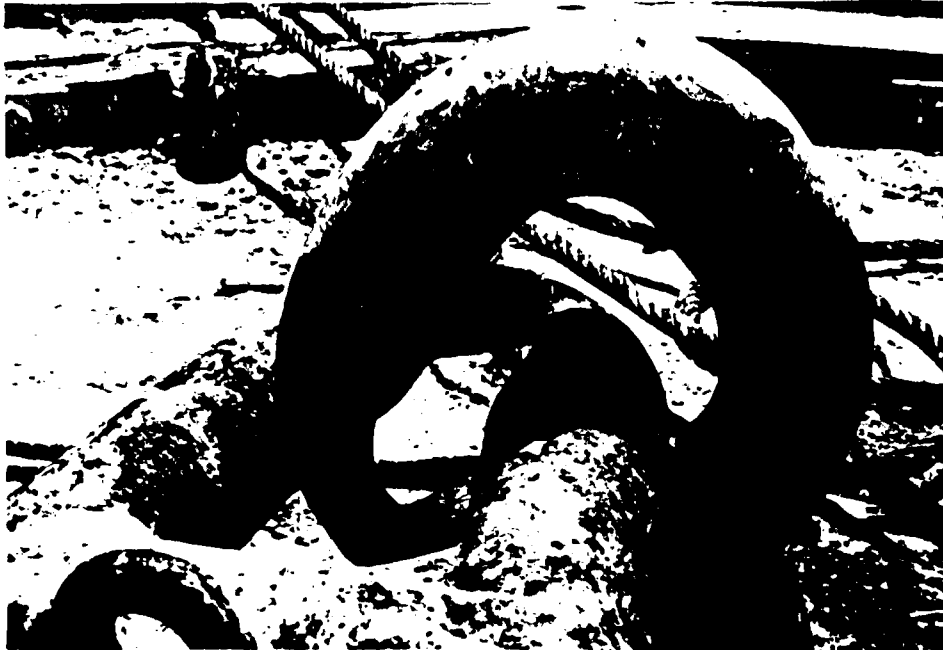
- The topside padeye on buoy OSCAR THREE shows extreme wear. In addition, components of this buoy's top jewelry are also severely worn. See photograph in Appendix B.

This buoy is a 12 foot diameter painted Peg Top (S/N 141) with a freeboard of 3'6". There is very little rusting on the buoy, and its overall condition appears to be satisfactory. The buoy has a partially rotted timber top fender. There is no fender at the water line. The two anodes attached to the buoy are in almost new condition. Their approximate measurements are 34" X 3" X 2". The topside padeye and connecting links are severely worn with some components measuring less than 50 percent of their original wire diameter.

Oscar 3 — Severely worn padeye

Due to the extreme wear of the buoy's topside padeye and associated hardware, it is recommended that these components be replaced as soon as possible. In addition, new fenders should be installed on the buoy.
